nRF54L15

nRF7002

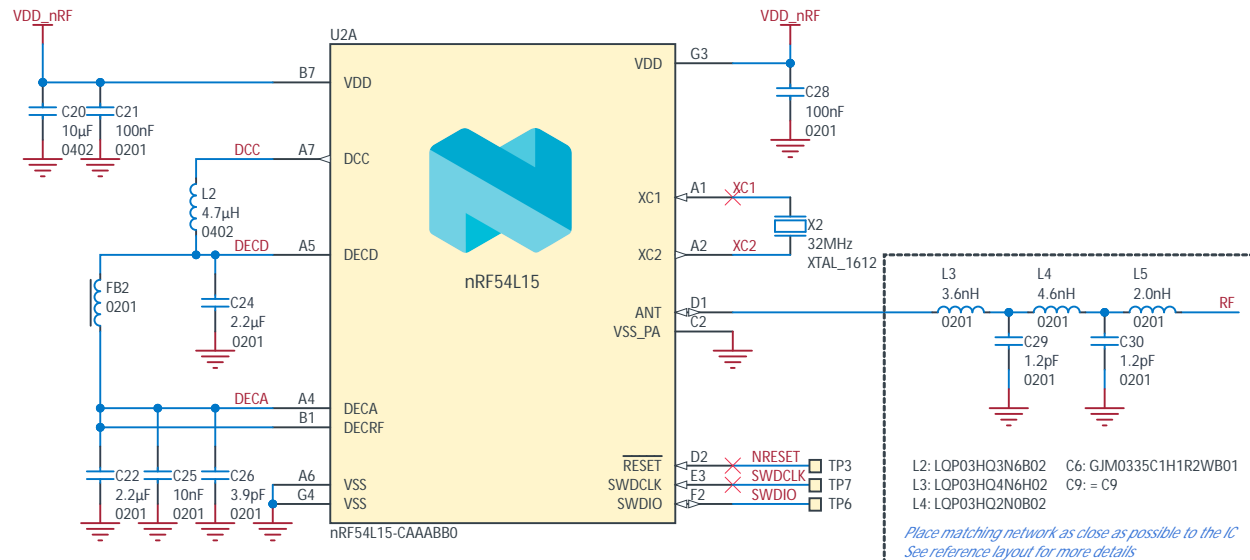
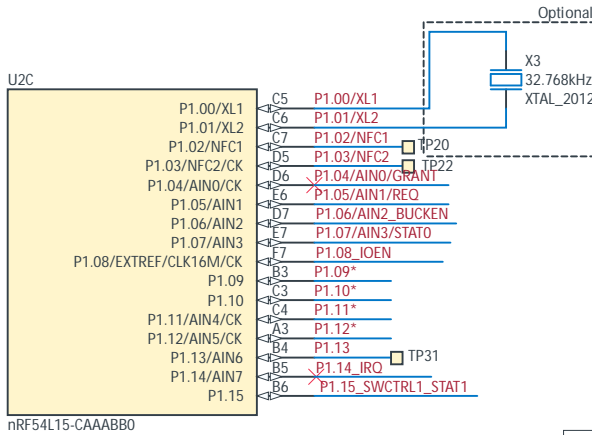
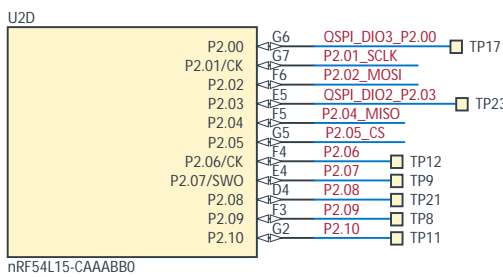
* Please refer to chip-level errata for GPIO pins P1.09, P1.10, P1.11 and P1.12: they are open and not used.

Customer IO's
